**Flood Control Project Maintenance
Levee Inspections**
LMA District Cover Sheet
Spring 2011 Levee Inspection Results

Reclamation District No. 2064 River Junction

Levee Inspection Report By Mile - Spring 2011

Waterway						Bank	Unit Miles	Inspection Start/End	Inspector	
Unit No. 01 San Joaquin River						Right	5.70	03/15/2011 03/15/2011	Herman Phillips	
LMR No.	Levee Mile		Category	Item	Location	Rating	Action/Comment	GPS Latitude/Longitude		Issue No.
	Start	End						Start	End	Photo
1	0.08	0.08	Earthen Levee	Vegetation	LS	A	Control annual grass and weeds on the levee slopes and easements.	°	°	10
								°	°	Y
2	0.08	0.08	Earthen Levee	Vegetation	WS	A	Control annual grass and weeds on the levee slopes and easements.	°	°	12
								°	°	Y
3	2.43	2.43	Earthen Levee	Trim / Thin Trees	WS	C	Tree stumps.	37.688097 ° -121.257790 °	37.688097 ° -121.257790 °	4
4	3.29	3.29	Earthen Levee	Trim / Thin Trees	LS	C	Tree stumps.	37.672717 ° -121.242518 °	37.672717 ° -121.242518 °	1
5	3.53	3.53	Earthen Levee	Trim / Thin Trees	WS	N	Tree stumps.	37.677080 ° -121.264268 °	37.677045 ° -121.264263 °	5
										Y
6	3.55	3.55	Earthen Levee	Trim / Thin Trees	LS	N	Tree stumps.	37.676801 ° -121.264203 °	37.6

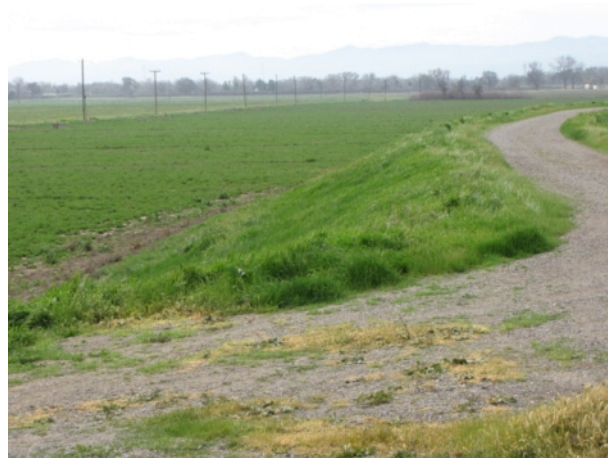
Levee Mile Report Line	1
Start Levee Mile	0.08
End Levee Mile	0.08
Location	Land Side
Category	Earthen Levee
Item	Vegetation

photo taken at leve mile 0.08 looking downstream from punping station in canal landward, growth of grasses covering shoulder and slope. This area was sprayed before it started raining, the rain has caused the weeds to grow back. The District plans to respray later during the summer. 3-15-2011 date of photo.

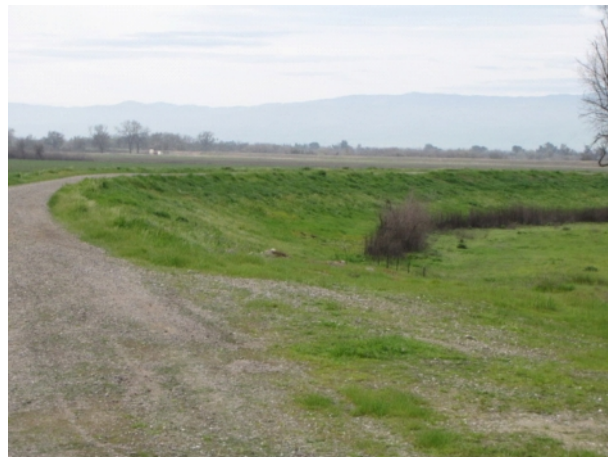
Levee Mile Report Line	2
Start Levee Mile	0.08
End Levee Mile	0.08
Location	Water Side
Category	Earthen Levee
Item	Vegetation

This photo shows the water side from levee mile 0.08 looking downstream. Photo taken 3-15-2011

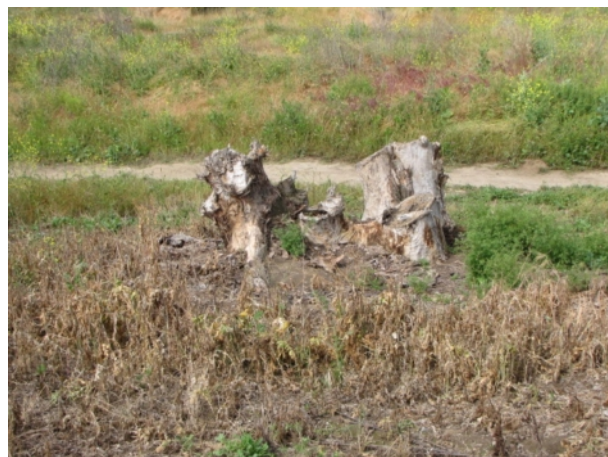
Levee Mile Report Line	5
Start Levee Mile	3.53
End Levee Mile	3.53
Location	Water Side
Category	Earthen Levee
Item	Trim / Thin Trees

Levee mile 3.53

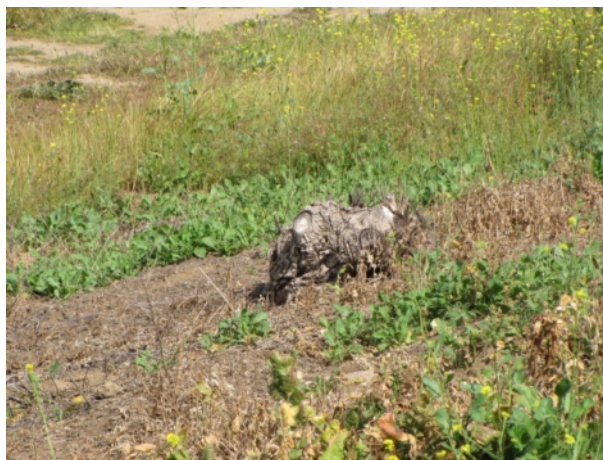
Levee Mile Report Line	6
Start Levee Mile	3.55
End Levee Mile	3.55
Location	Land Side
Category	Earthen Levee
Item	Trim / Thin Trees

levee mile 3.55

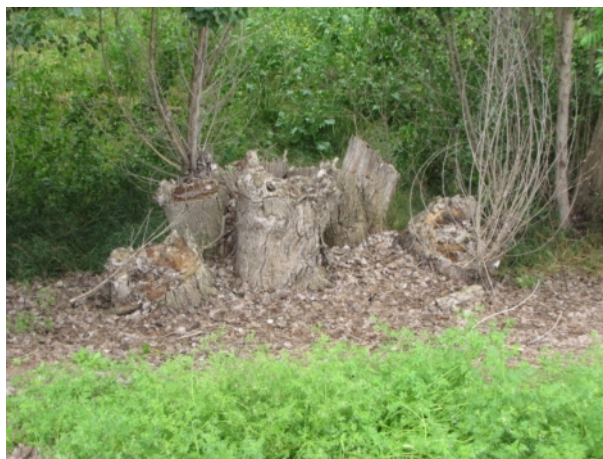
Levee Mile Report Line	7
Start Levee Mile	3.66
End Levee Mile	3.66
Location	Land Side
Category	Earthen Levee
Item	Trim / Thin Trees

Levee mile 3.66 waterward toe.

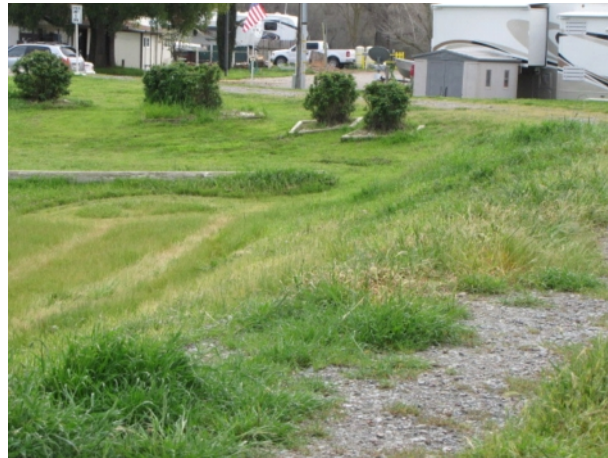
Levee Mile Report Line	1
Start Levee Mile	0.00
End Levee Mile	0.00
Location	Land Side
Category	Earthen Levee
Item	Vegetation

This photo taken at gate looking downstream from levee mile 0.00 landside slope. Photo taken 3-15,-2011

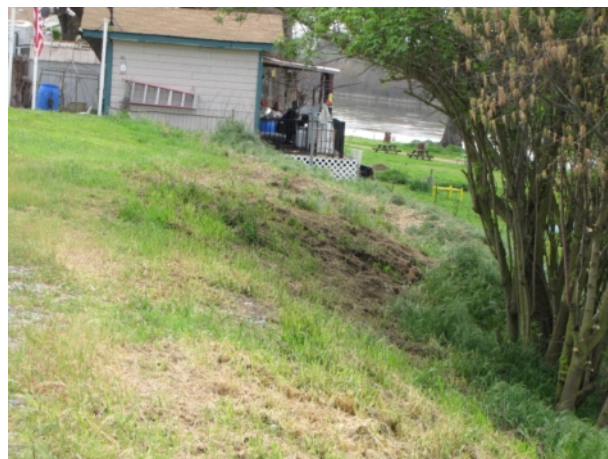
Levee Mile Report Line	2
Start Levee Mile	0.00
End Levee Mile	0.00
Location	Water Side
Category	Earthen Levee
Item	Vegetation

Photo taken from waterside looking downstream from gate at levee mile 0.00 Two Rivers Traylor Park and Stanislaus River in view. This photo taken 3-15,-2011

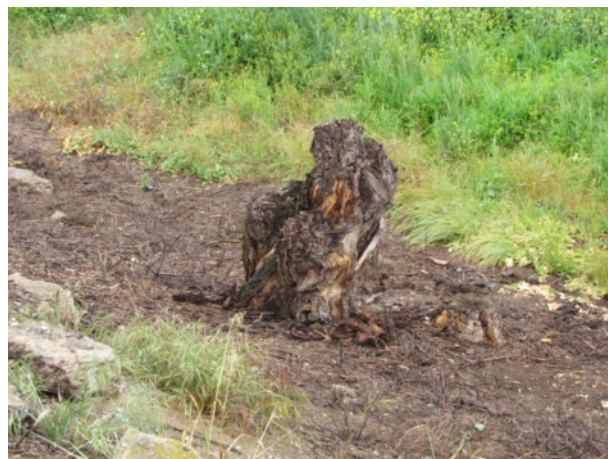
Levee Mile Report Line	3
Start Levee Mile	0.99
End Levee Mile	0.99
Location	Water Side
Category	Earthen Levee
Item	Trim / Thin Trees

levee mile 0.99
